Information Regarding
Water - Sewer & Drainage
in Shorts Sands Area

PLEASE NOTE: These Reports ARE taken
out of Context. You can
find & READ all full Reports
on the Town of York
WEBSITE

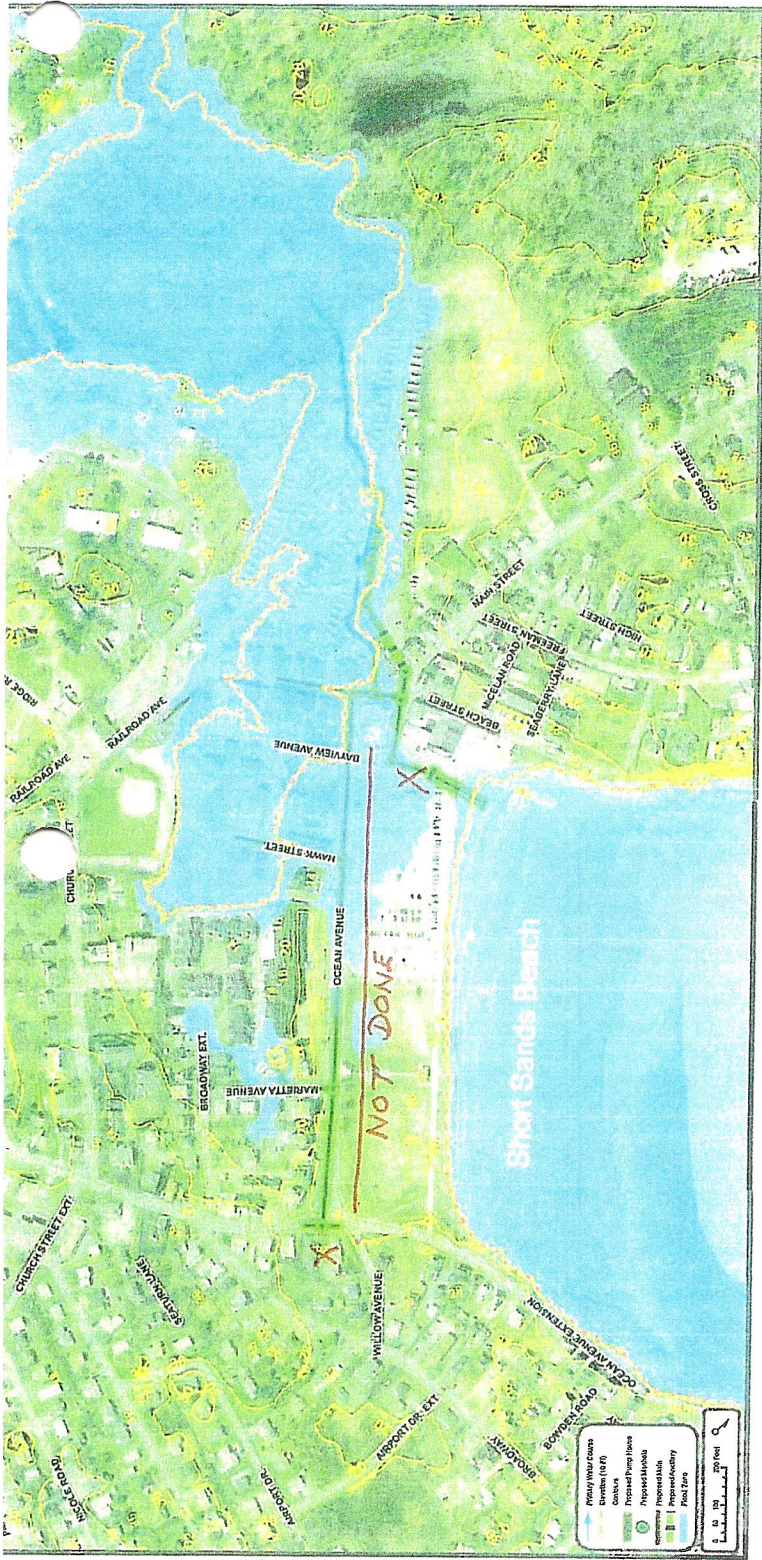
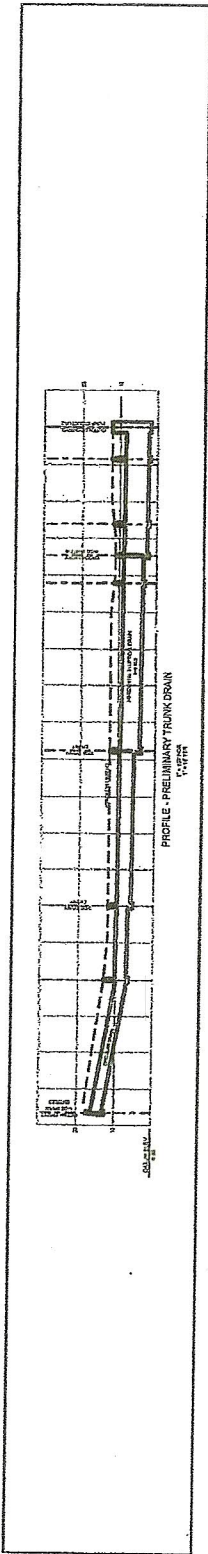
Map and Profile of Short Sands Beach

The X's are the areas completed from mid October 2010 to April 2011. The entire portion from X to X running along Ocean Avenue IS NOT DONE and will not be done until sometime in 2012.

ALL of the Blue Area above Short Sands Beach is FLOOD ZONE.

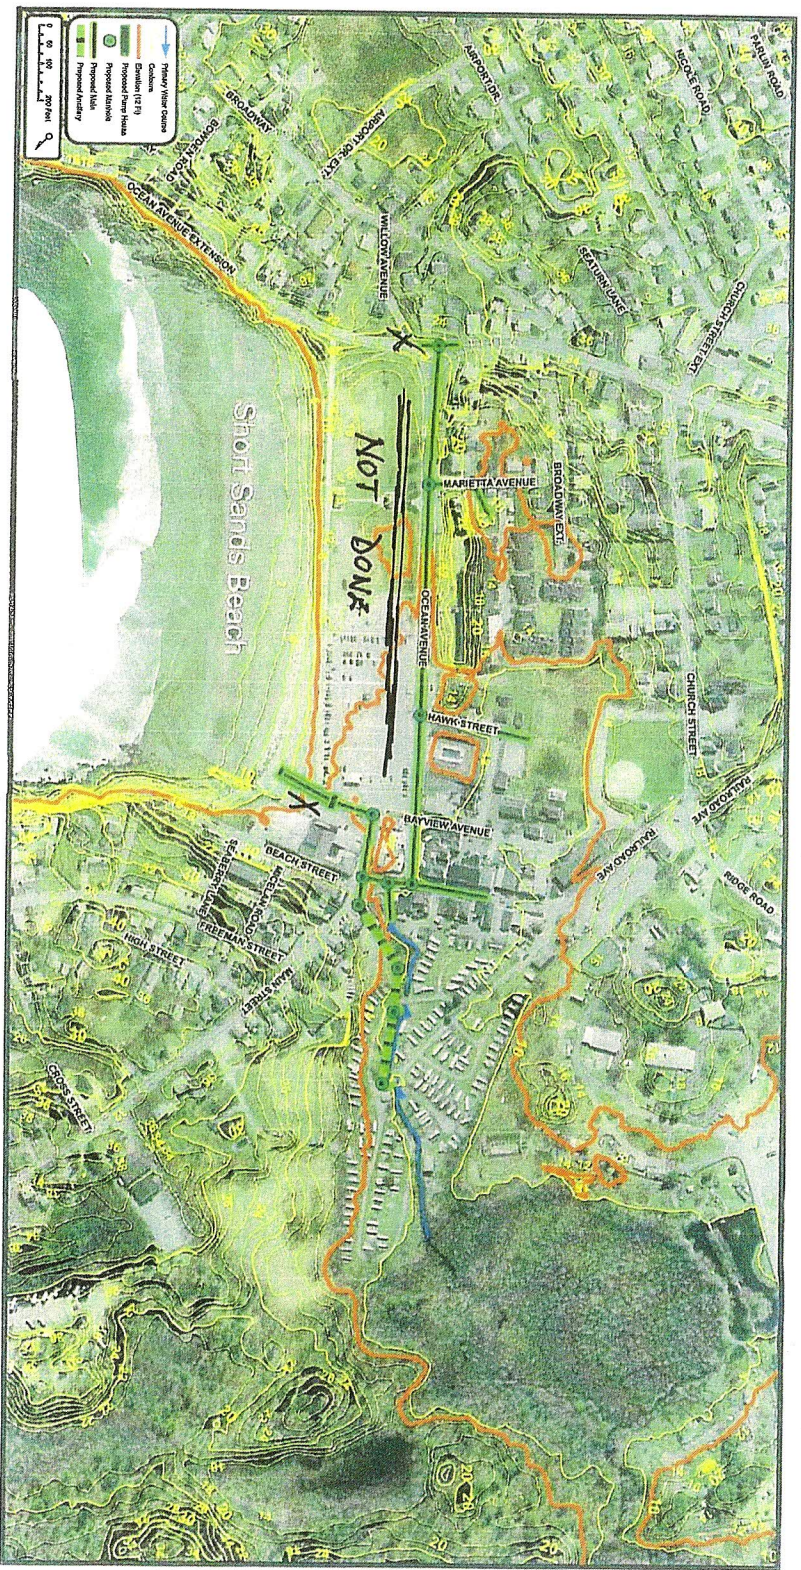
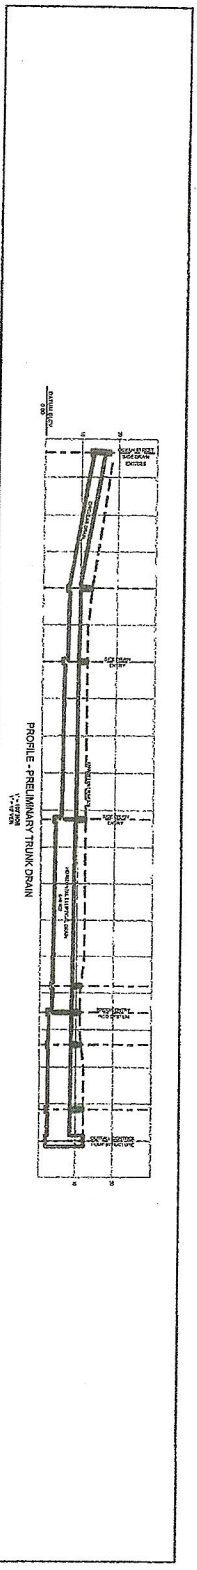
Map and Profile of Short Sands Beach

All of the Red lines are elevations of 10 to 12 feet. The Black line indicates not to be done until next year (2012). X = completed.

HIGHLIGHTED area is being put off until 2012.

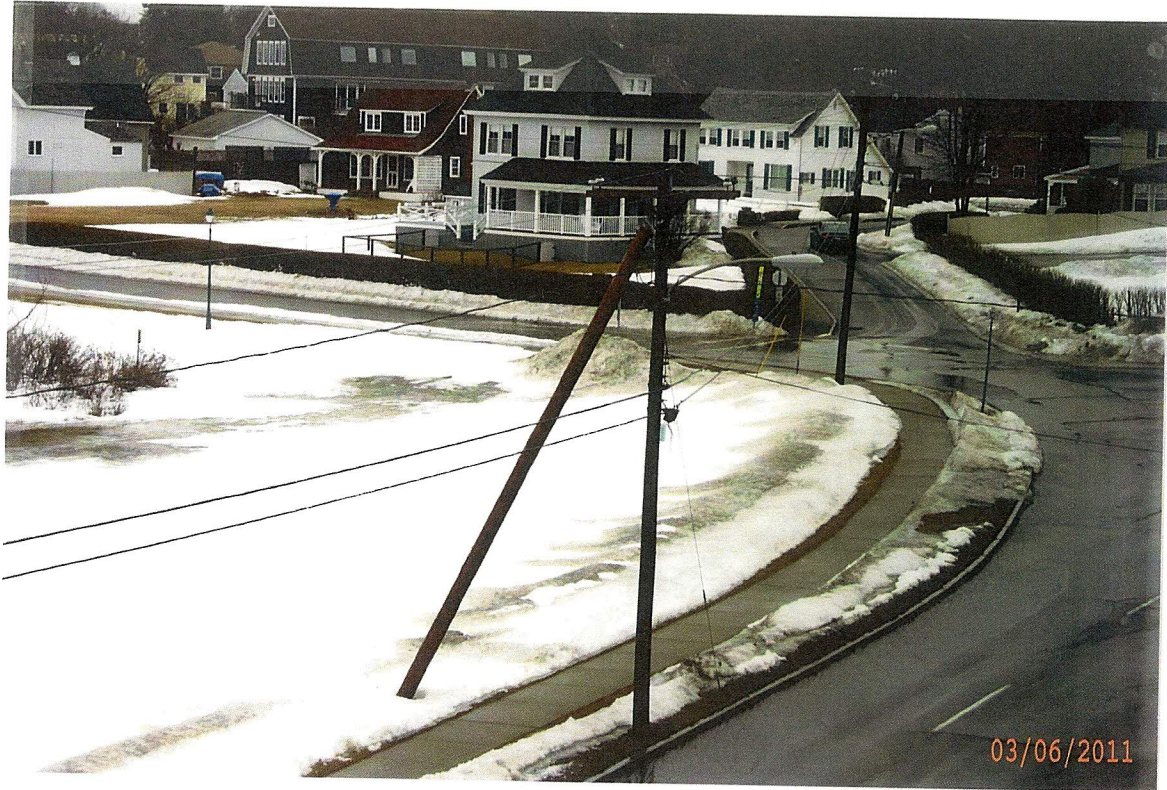
This puddle at Willow - Ocean Ave & Ocean Ave Ext.
was so deep - even large trucks had trouble going
through it.

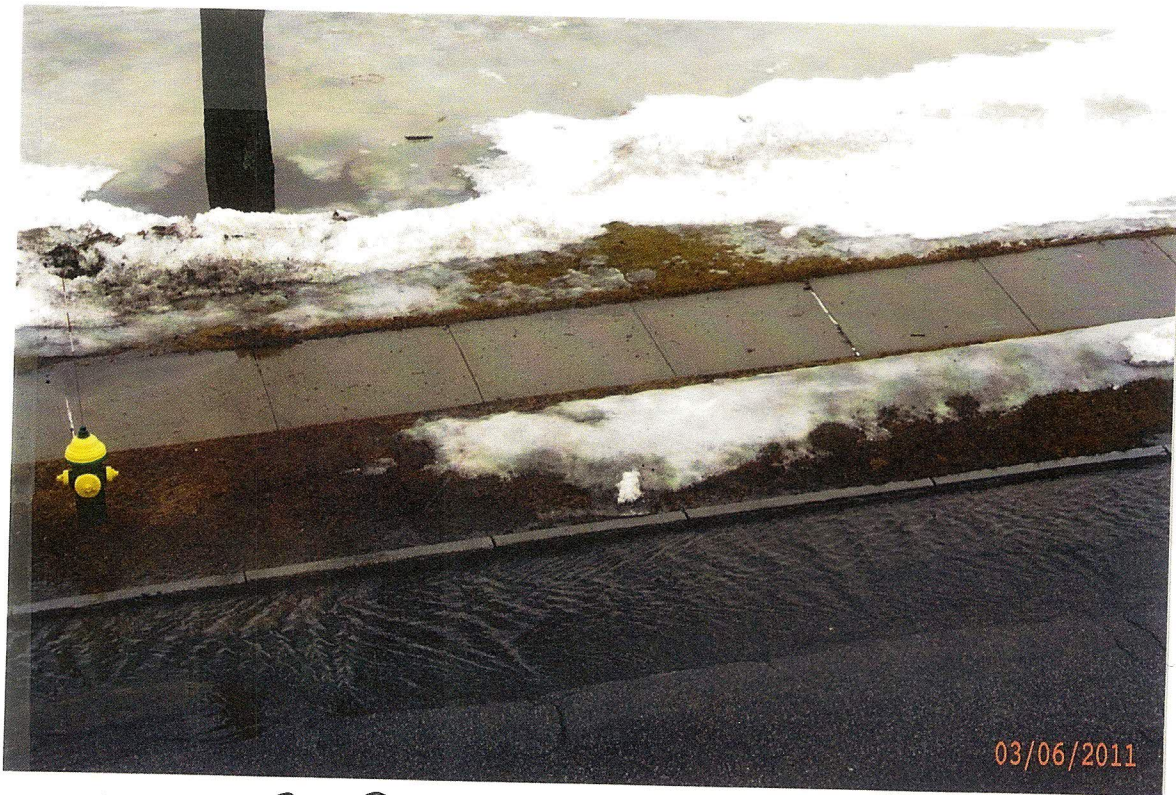
Just Gushing Past our Condo

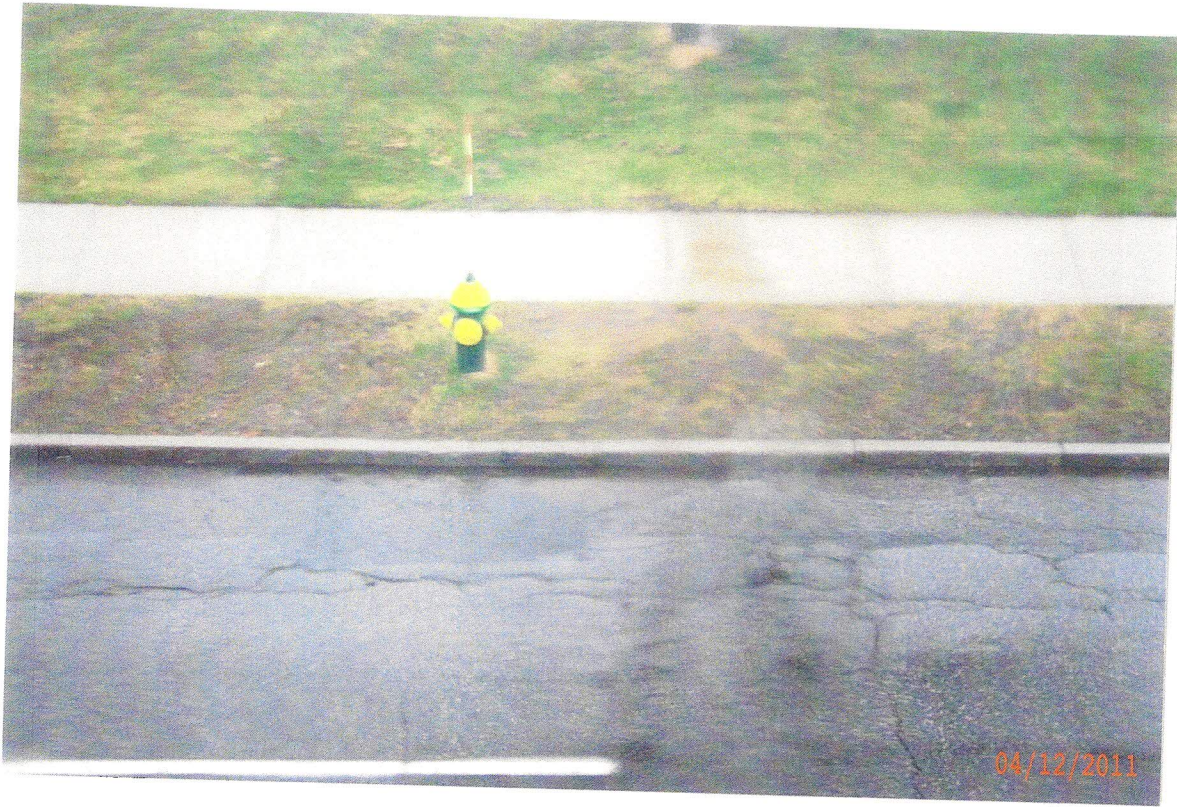
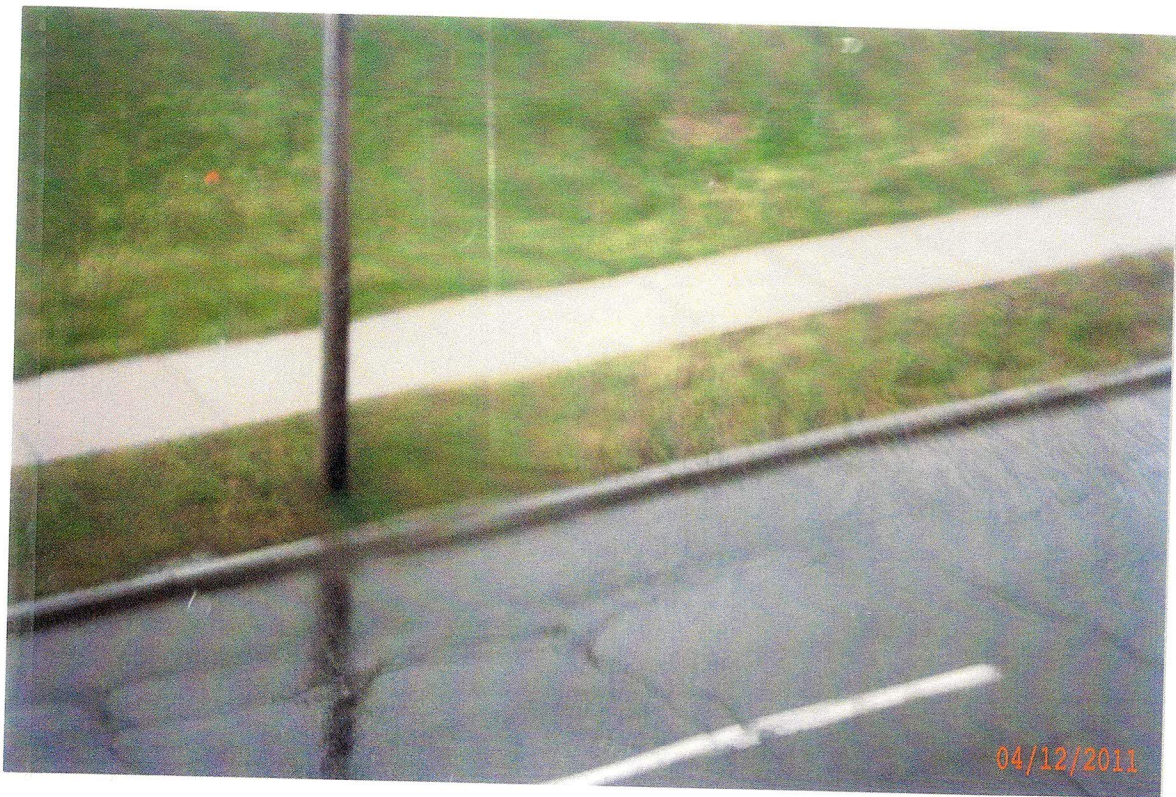
If that is Surface Water - What do you think
the Ground Water Flow is doing?

Water that was supposed to be diverted AWAY from us

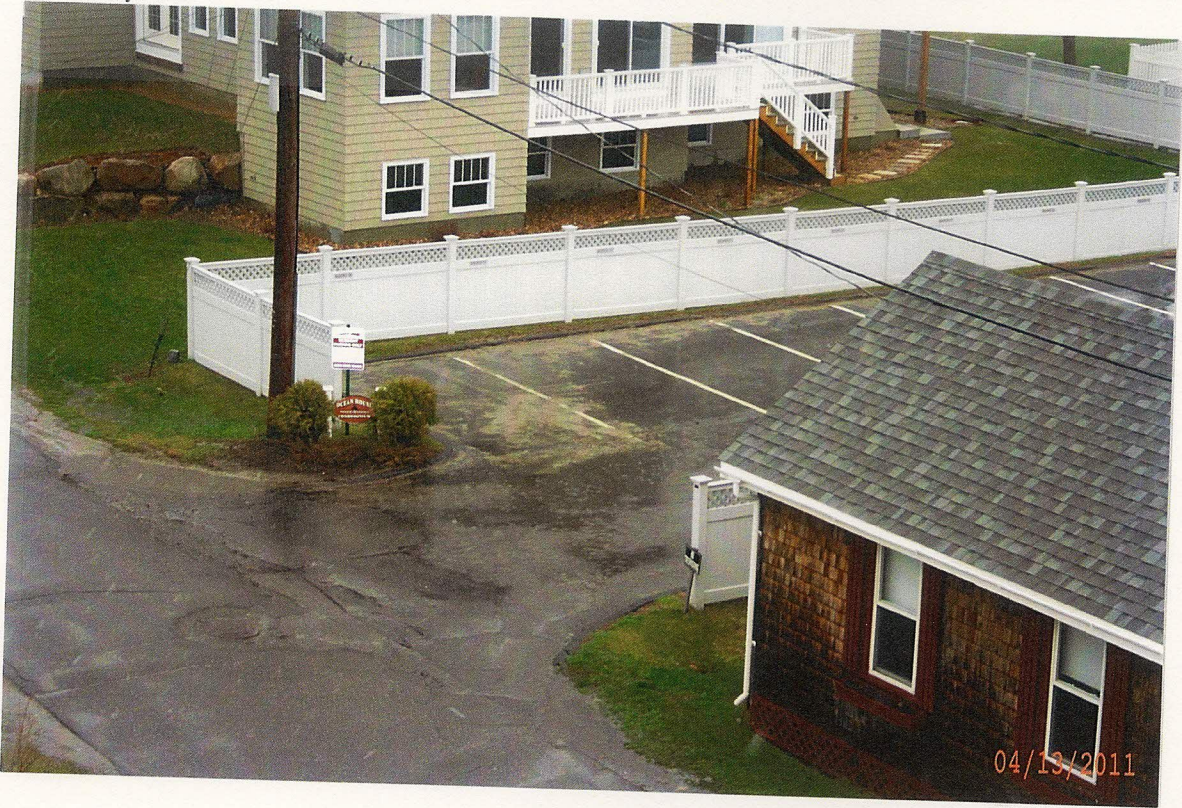
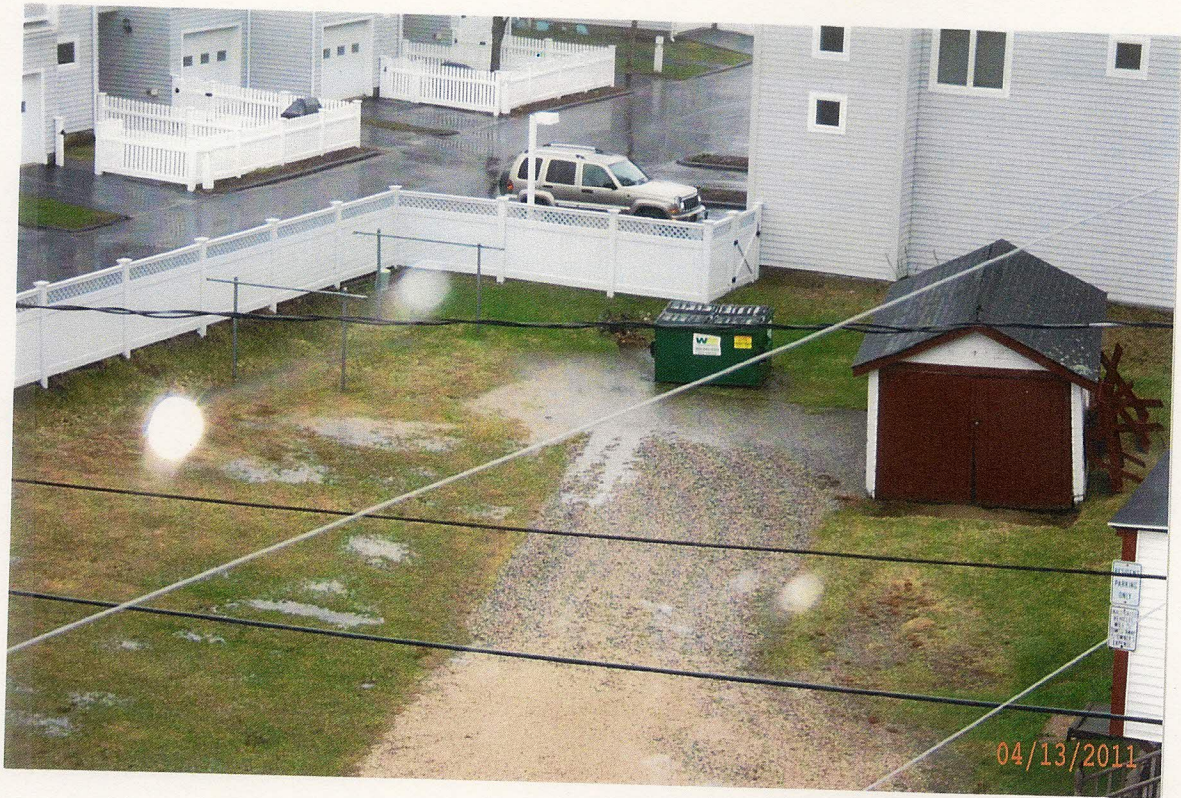
THESE PICTURES WERE TAKEN AFTER ABOUT 2 HOURS OF RAIN

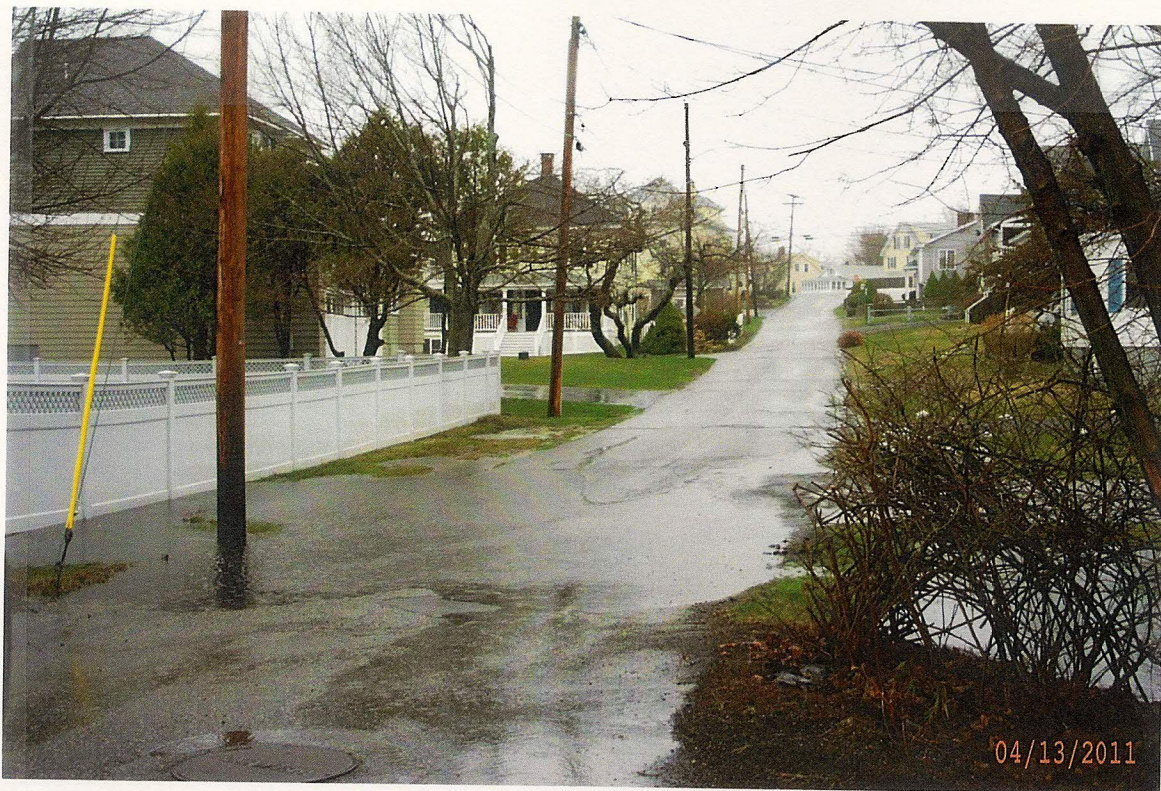
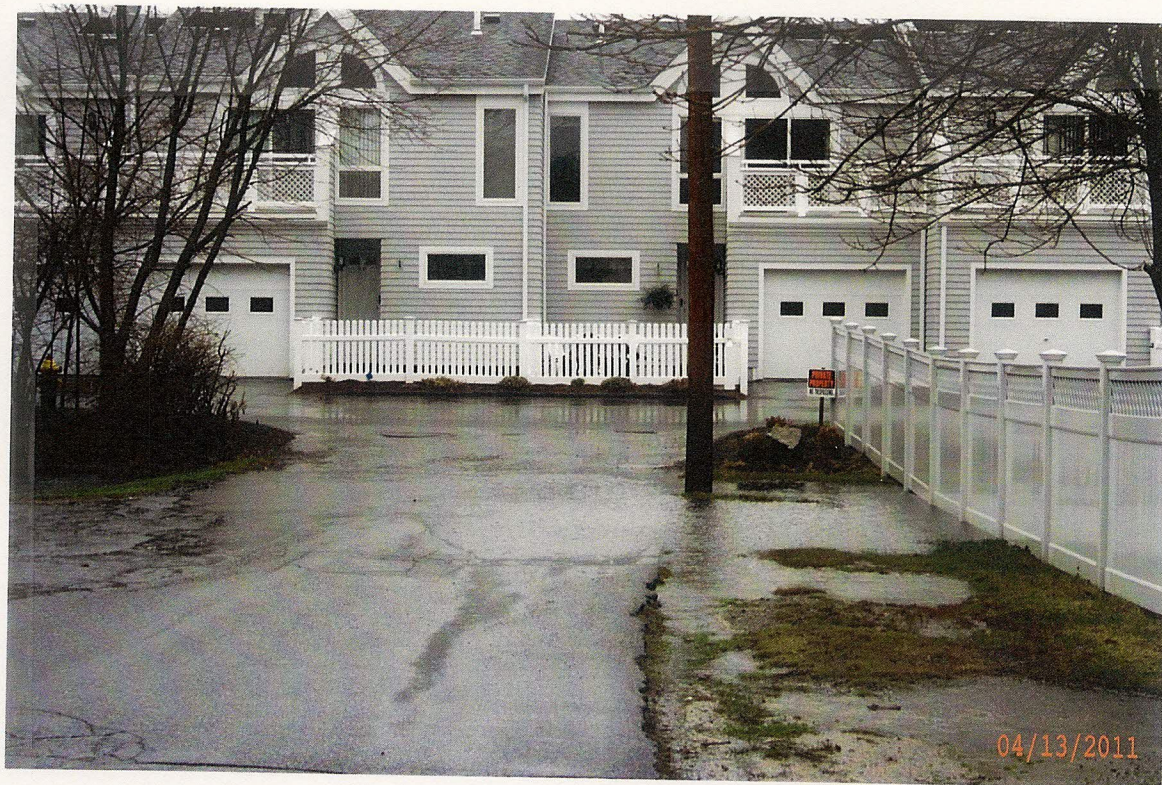
These pictures were taken after rain stopped
